# KEEPING THE ELECTRICALS COOL

by Paul Cortes

# PRIUS INVERTER COOLING

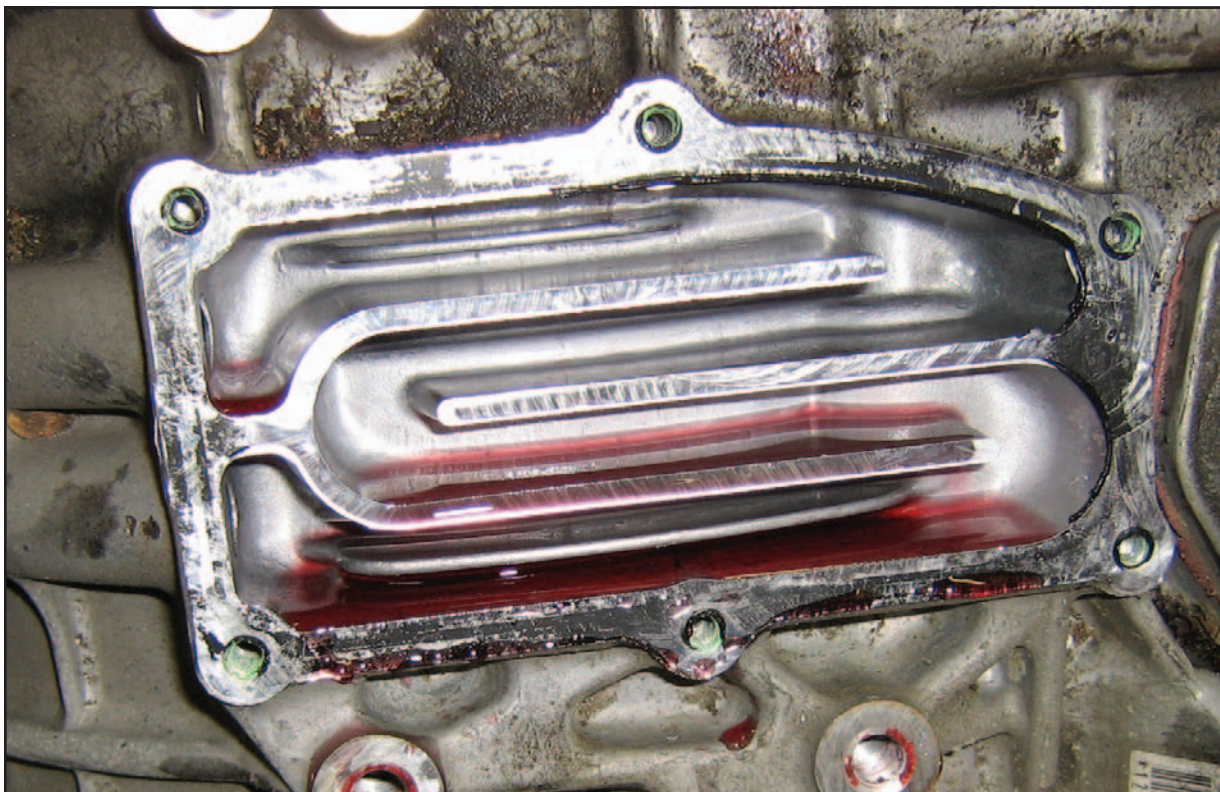
The M62 heat sink is on the very top of the transaxle. It's hard to remove air pockets from this area without a vacuum fill tool.

best way to ensure no air is trapped when refilling the system. Depending on the design of the vacuum fill tool, you may also need a cap adaptor.

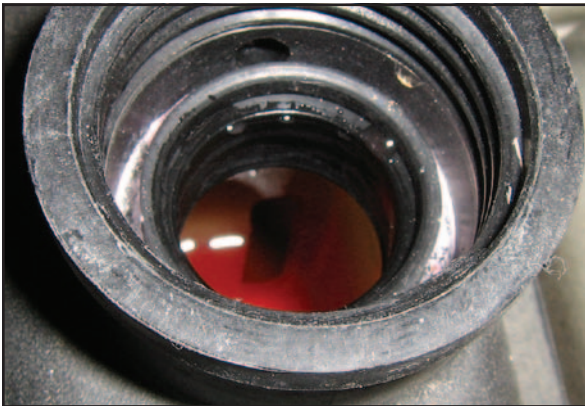
If the coolant is still or barely moving, there's a problem.

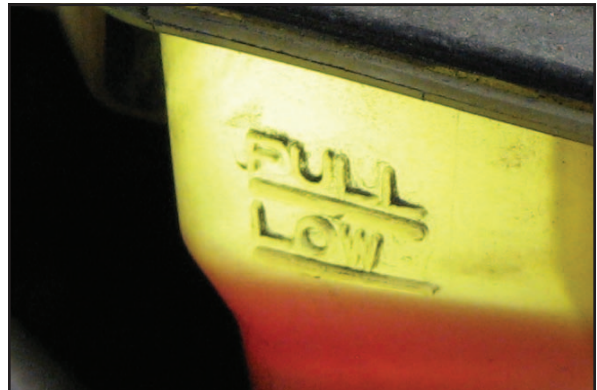
The inverter reservoir can become opaque as it ages. A flashlight is helpful when checking the level.

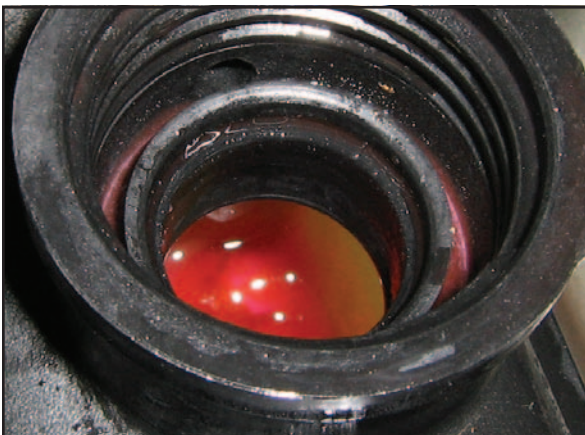
When the pump is working properly, you should see a fair amount of turbulence.

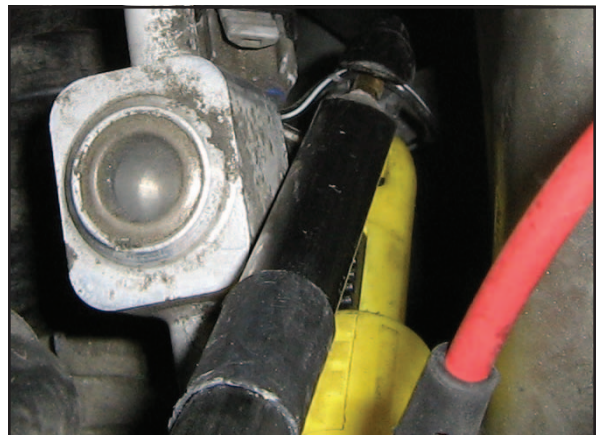
Use a seam splitter to slit the protective sheath, and then use piercing probes to check voltage.

placid pool of pink tranquility under the cap, check for voltage across the two-wire connector at the inverter pump with the power mode in READY or ON. No coolant flow + Battery voltage across the inverter pump = Bad inverter pump. Simple huh? Flat rate diagnostic guys rejoice!

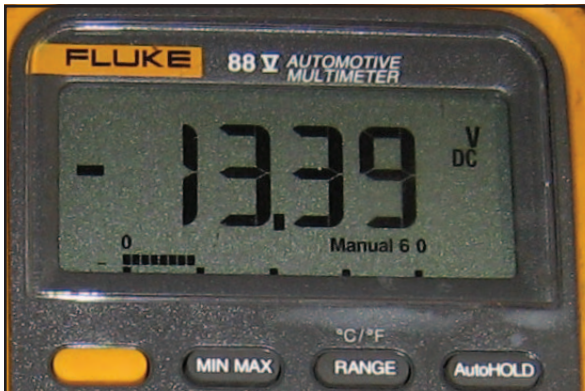
If the pump is powered, coolant should be flowing.

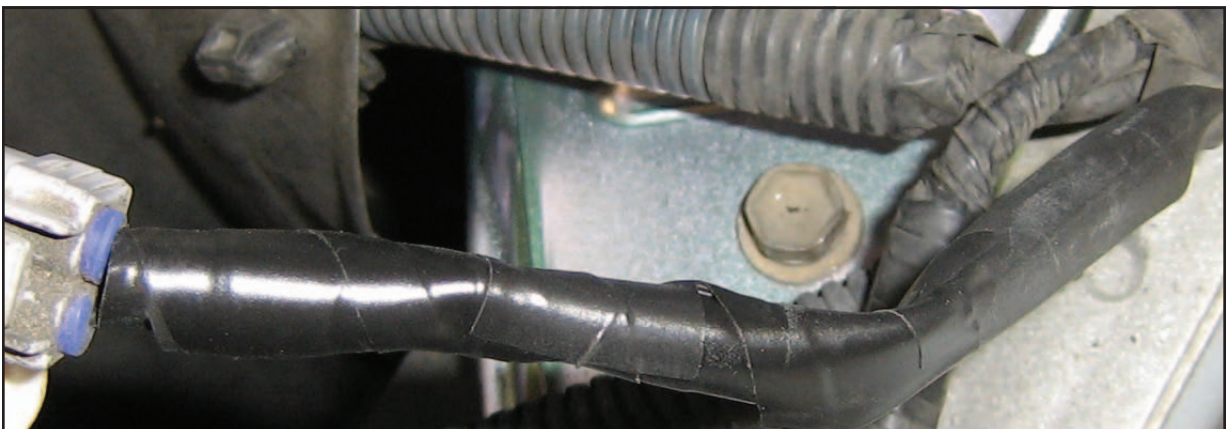
Piercing probes can save a lot of time and can often provide more reliable contact than back-probing, but always remember to repair any insulation holes and rewrap the harness.

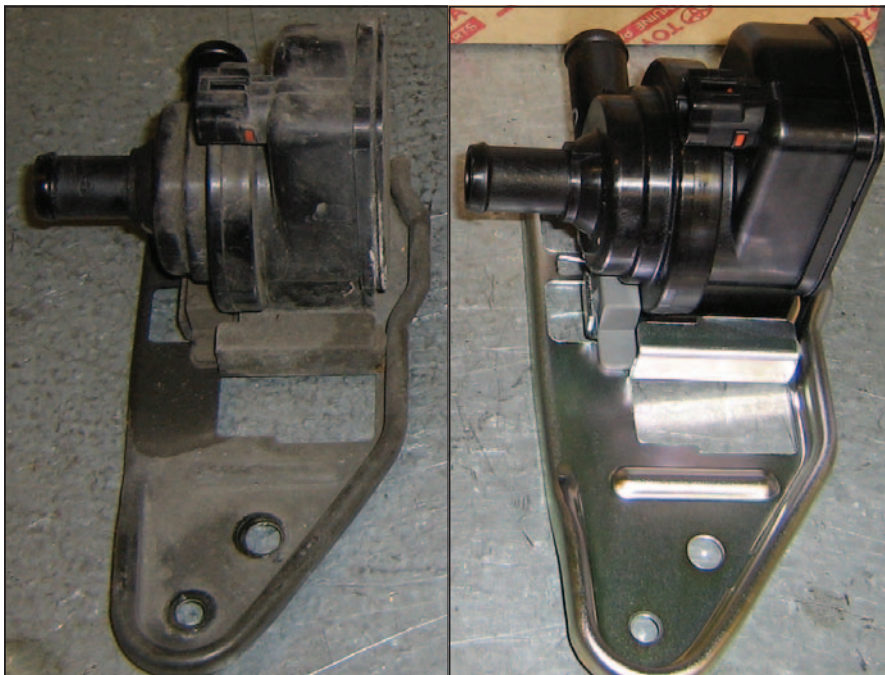
The redesigned Gen 1 inverter pump can be identified by the silver colored bracket.

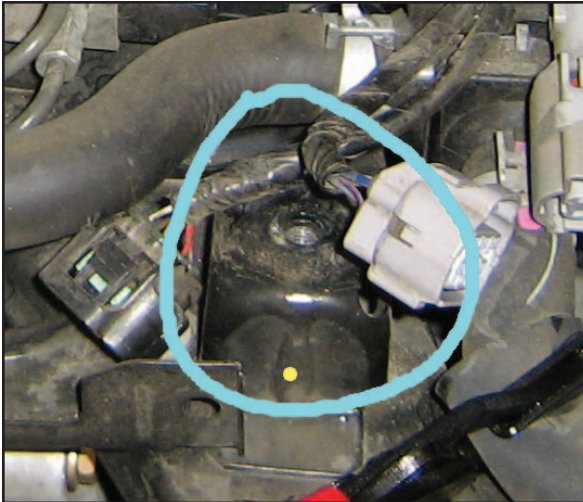
The rear inverter mounting point is circled.

- While not directly related to the inverter cooling system, you may encounter the following during cooling system repair: When the inverter is hit, the rear mount bracket is often bent. If you remove the two front mounts and the inverter goes "SPROINGNGNG!" as it jumps up a few inches, this is probably the case. The ABS/VSC actuator is mounted to the rear mount bracket. If you've never done one, plan on it taking at least six hours. This job cannot be done without the Techstream since you'll need it for ABS bleeding and calibration.

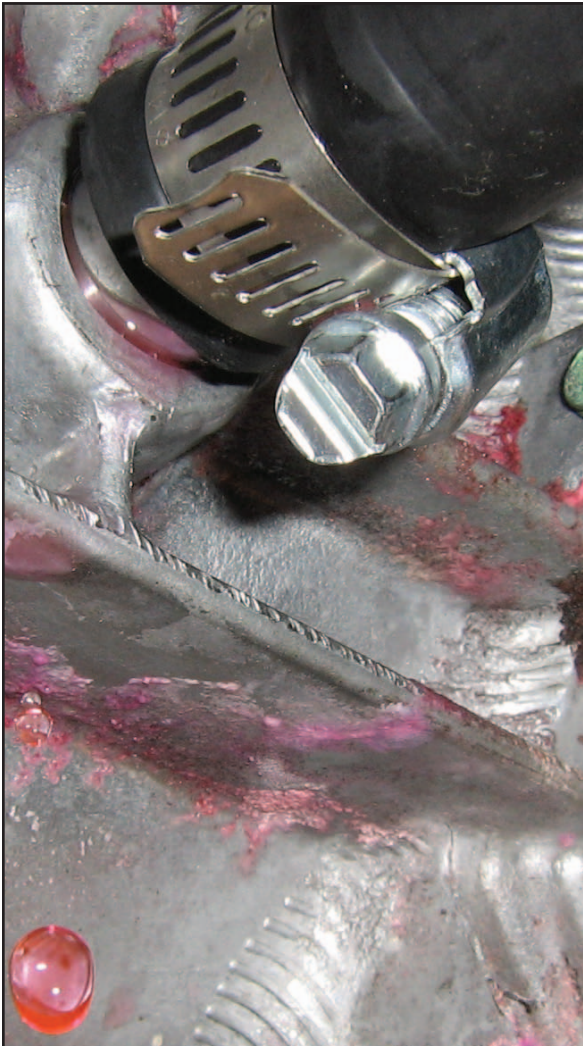
A new hose clamp won't fix this one.

■ Transaxles can be damaged at the coolant fittings. Sometimes body shops will figure the leak is coming from the hose, install a hose clamp and then assume it's fixed. I've seen post-collision-repair leaks from these fittings twice now. There's only one "right" fix: a new transaxle, an option that's bound to be unpopular with your customer or their insurance company.

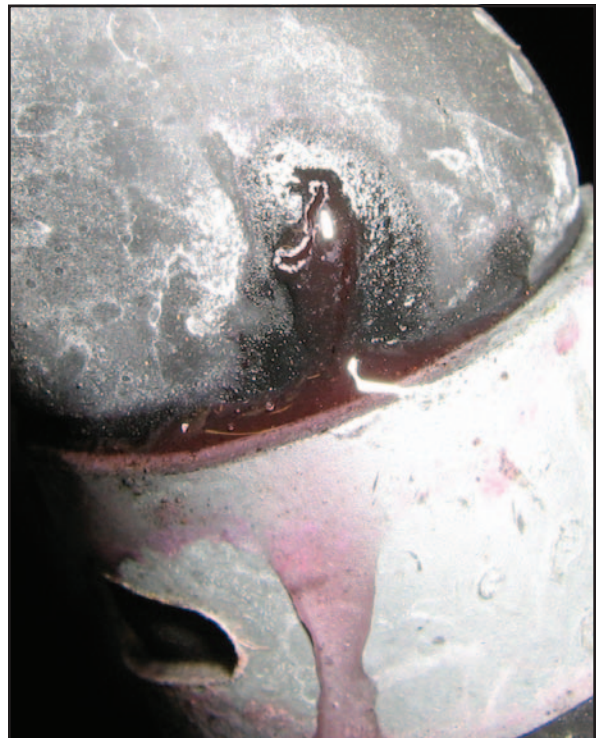
■ Toyota hoses are of superior quality, so it's unusual to see a leaking hose even after eight years of service. However, hoses do get damaged during collisions or repairs. You may need a mirror and some patience to fully inspect all of the inverter system hoses.

This hose was pinched.

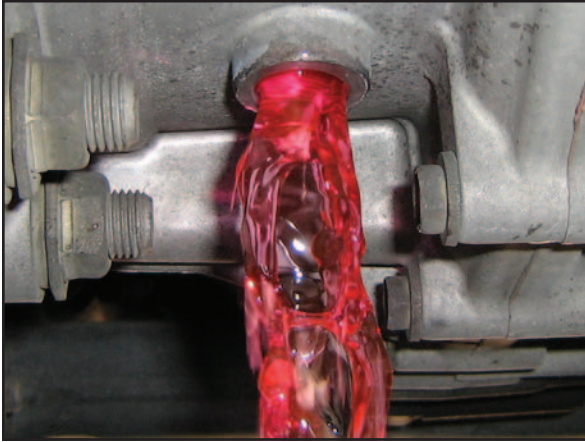
1. Remove the inverter reservoir cap, then remove the inverter drain plug in the transaxle.

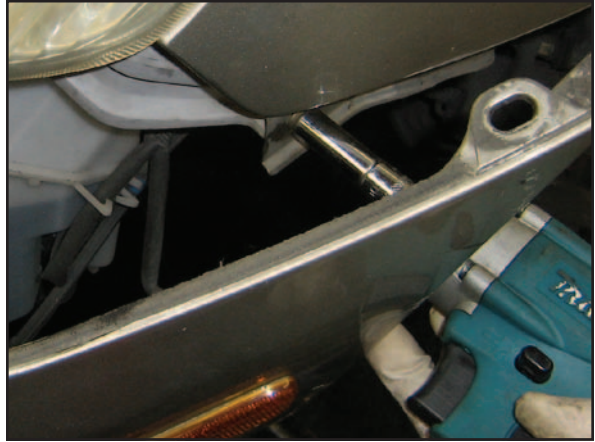
3. Here is the hidden headlight nut. The other two fasteners are on the top of the headlight housing in plain sight.

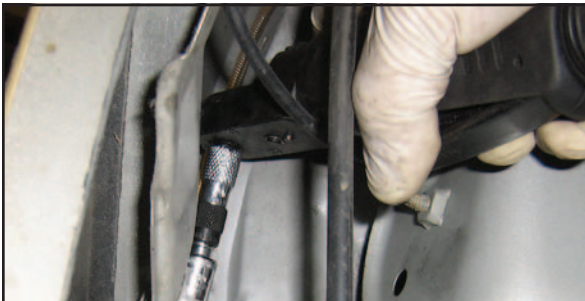
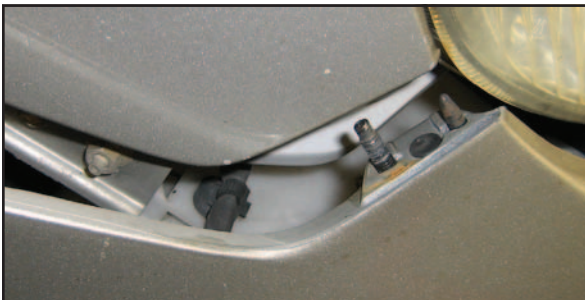
2. Remove the bumper cover. This is necessary because the bumper blocks access to one of the headlight bolts. Most of the bumpers fasteners are obvious, except for the two nuts hidden in the wheel well.

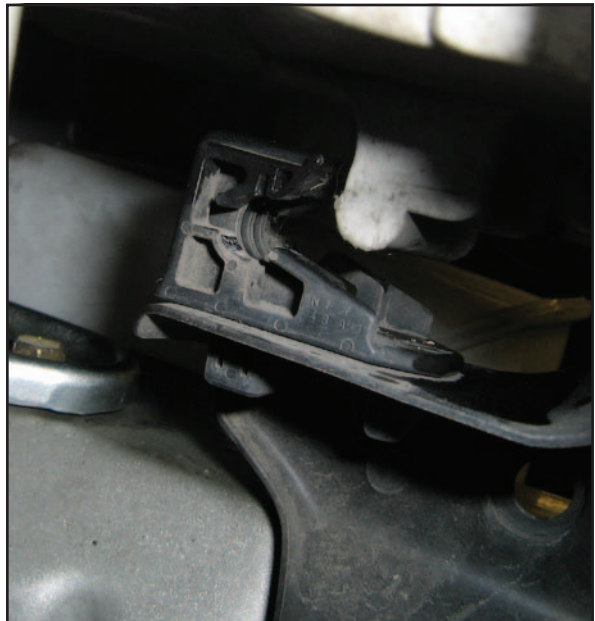
4. There is a retaining clip in the inner lower corner of the housing. Just pull the headlight housing towards you to release it.

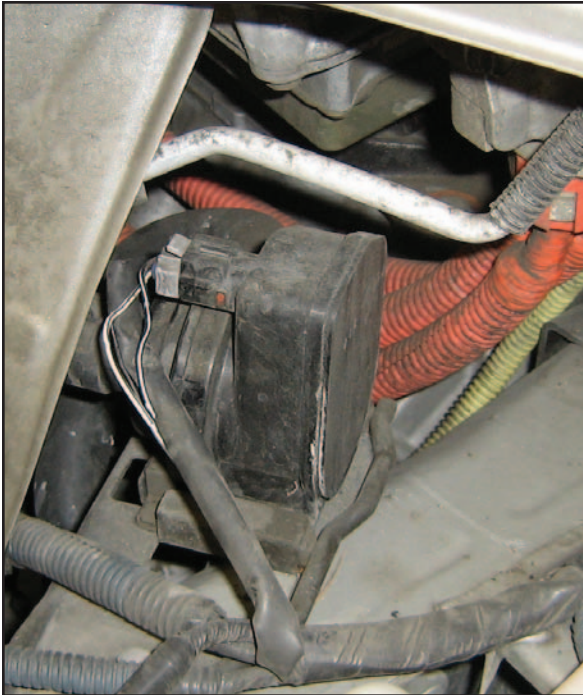
5. Once the headlight is out of the way, the pump is easy to access.

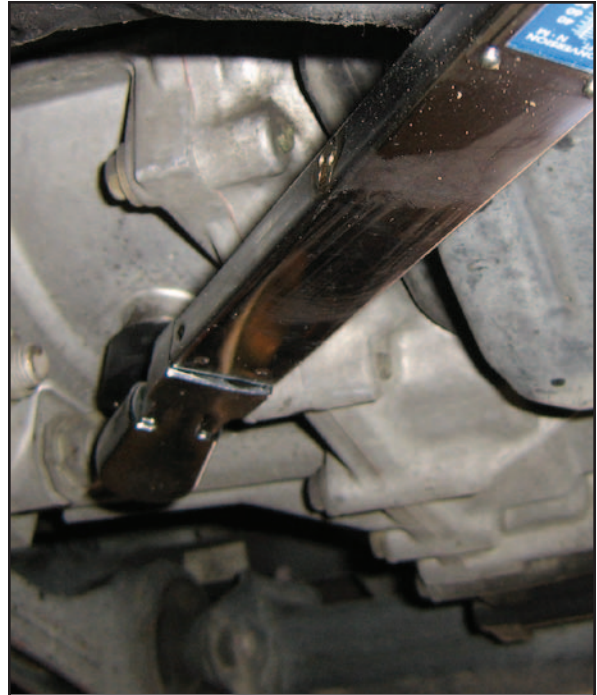
Install the inverter drain plug and torque it to 29 ft/lb.

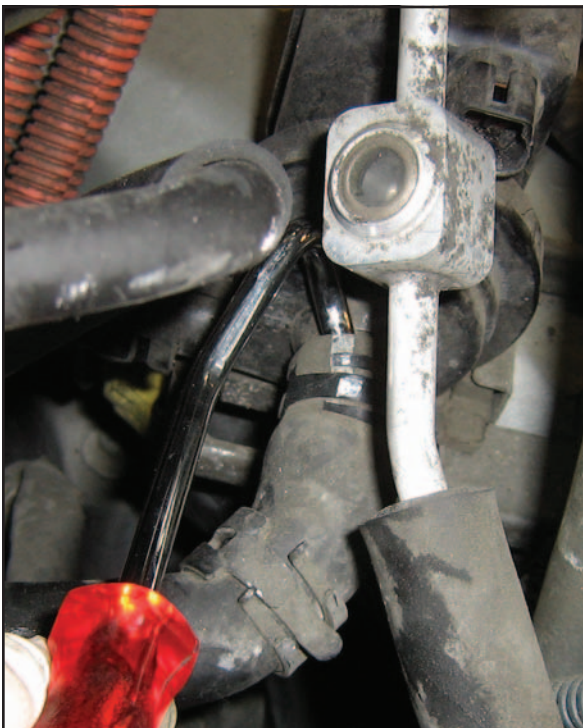
If you are planning to reuse the hoses, use a hose pick to separate the hoses from the inlet and outlet.

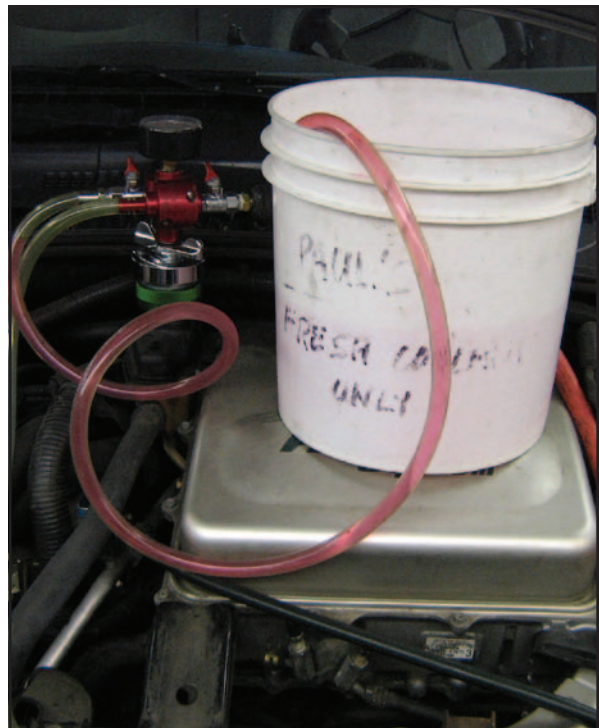
Use a vacuum fill tool to fill and bleed the system.
